## SHORT ARTICLE

## About the need for an assessment on the risk of pollution from the fuel on board the shipwreck of the former USS Peacock in the Bay of Cartagena de Indias

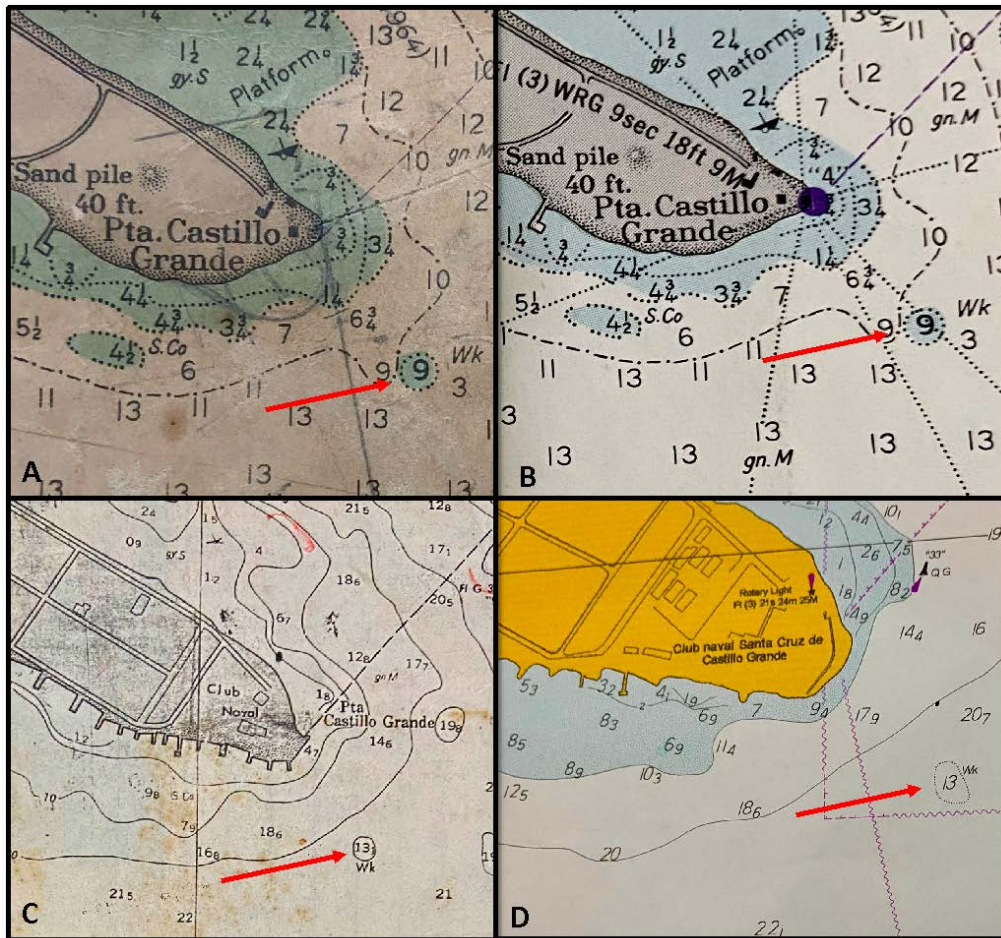
**Figure 1.** The wreck's position on navigation charts: (A) On chart US 24505, Rev. 1966. (B) On the same chart updated in 1976. (C) On chart COL 262 from 1982. (D) On chart COL 840 from 2000 (indicated as Wk)

The wreck of the Peacock has been marked in Notices to Mariners and incorporated into nautical charts since the time of its sinking, as shown in Figure 1. More recently, the wreck has been visually visited and inspected through diving operations since July 1992 by the Marine Infantry Special Forces and the Diving and Salvage Department of the Colombian National Navy. Since then, the wreck has been continuously visited and has become a mandatory location for diver training in low-visibility inspections. From the earliest dives, it became evident to the divers that the ship’s internal structure retains a large quantity of “black droplets” that rise to the surface (fuel oil drops) and mark the wreck’s location, which has always raised interest and concern due to its proximity to the city.

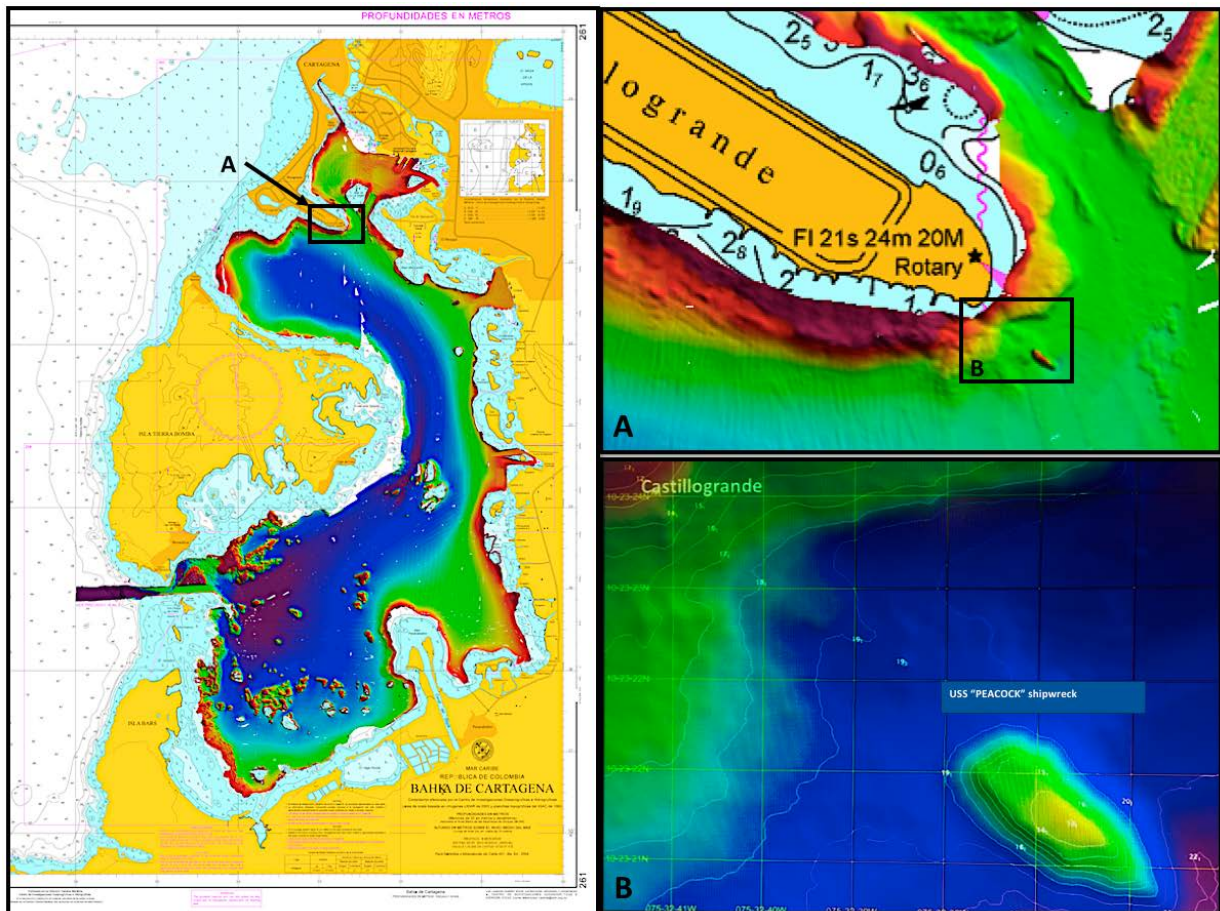
**Figure 2.** Bathymetric surface, created using a multibeam sonar, overlaid on nautical chart COL 261 on order to identify features in Cartagena Bay (Mora *et al.*, 2018). In the Cuatro Calles area (**A**), the anomaly representing location of the wreck (**B**) can be observed in the navigation channel in front of the Castillogrande peninsula.

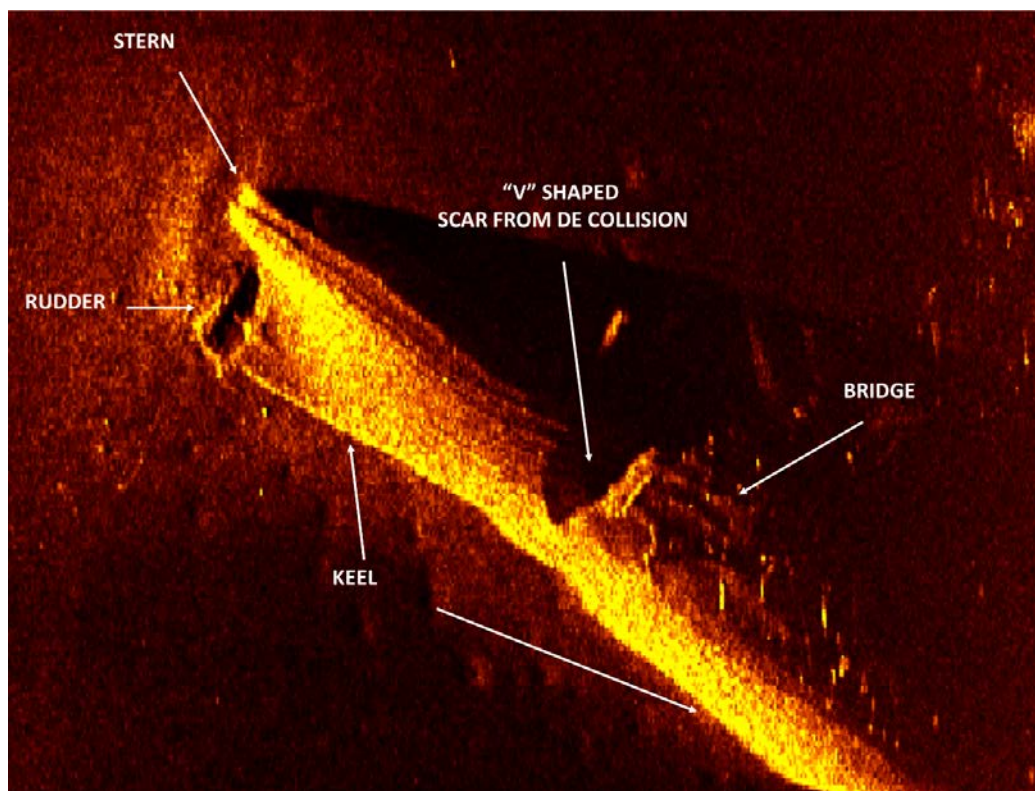
**Figure 5.** Side-scan sonar image (600 kHz) of the wreck of the tugboat USS Peacock in the Bay of Cartagena. Note the V-shaped scar on the hull resulting from the collision.

The side-scan sonar image (Fig. 5) shows that the ship rests on its port side in one piece, with a deep V-shaped scar near the engine room, a result of the collision with the MS Hindanger

Images from sonar surveys indicate that the ship's structure is still well-preserved. However, dive inspections report that the structure is completely encrusted, especially in the shallower part, up to about 17 m in depth, which is the lower limit of the oceanic water that is more transparent to sunlight. A significant amount of fine silt has accumulated on top of these encrustations. Additionally, reports indicate that metal deterioration is evident in many places on the starboard side. Further aspects of the wreck can be found in Santos and Rojas (2015) and Andrade (2021).

The author's opinion is that this is a chronic problem that must be confronted. It is urgent to invest in ensuring the environmental health of the Bay of Cartagena, especially along the coast of Castillogrande. In this regard, it is essential to conduct a detailed inspection of this situation. If there is a significant amount of fuel on board the USS Peacock, solutions must be found to extract it from the ship because a leak from a fuel oil tank within the bay could be disastrous. If there is fuel on board, the question is not whether a leak will occur, but when it will happen.
