Determination of the coastal morphological variation of the bay of Tumaco, from multi-temporal analysis with remote sensing

DOI: 10.26640/22159045.439

Diana C. Niño P.* & Fernando Oviedo B.**

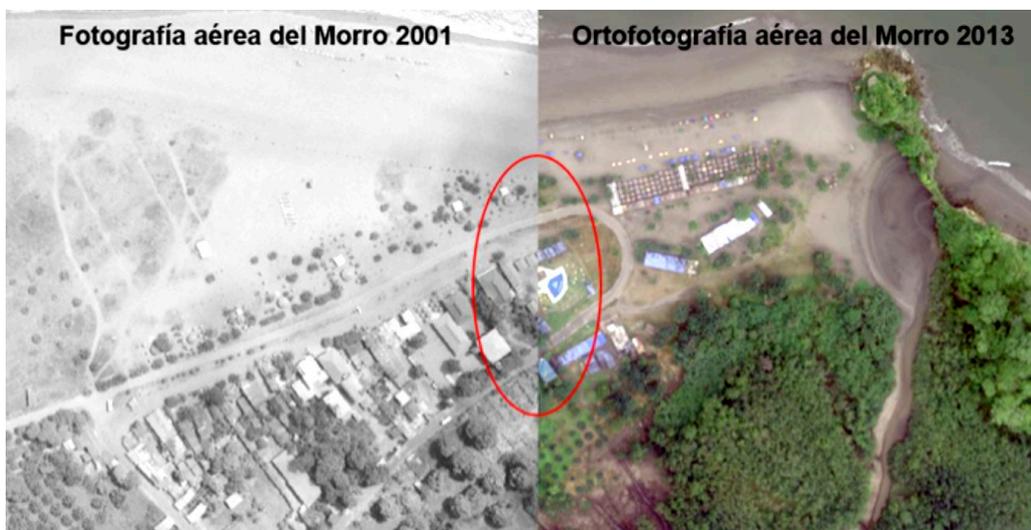
Figure 2. Example of aerial photograph georeferencing .

of the project "Physiographic Zoning of the Pacific Coast, Phase I" in 2013. During that process care was taken on each georeferenced photograph had very good positional exactitude and a low mean quadratic error, to guarantee no distortion (Figure 2).
